CHAPTER 7

EVALUATION PROCESS

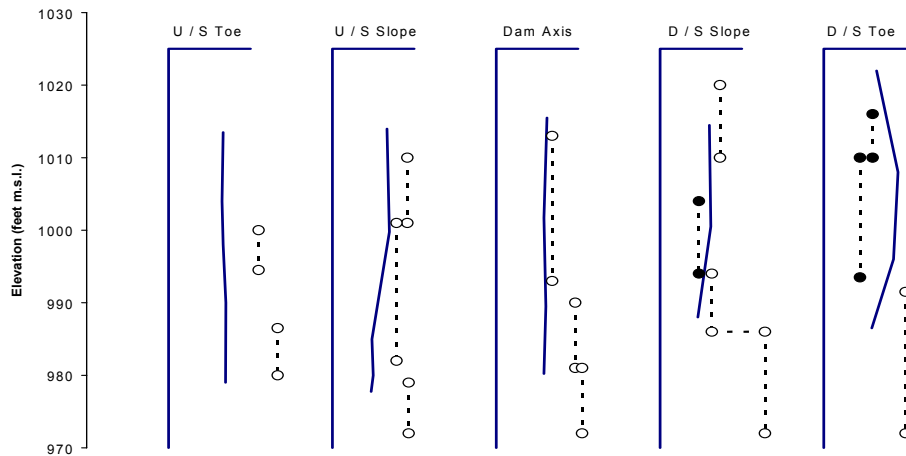
a. Stations 25+00 to 33+00.

(4) Figure 7.1.a&b shows that in the zone of closure section (stations 33+00 to 35+00) and to the west (stations 25+00 to 33+00) the sand under the downstream toe and slope is liquefiable and on the upstream side is non-liquefiable or marginally liquefiable. However, in these reaches the soil liquefiability was evaluated based on only one boring in each characteristic location (toe, mid-slope) so that these results should be verified by additional investigation in Phase III, Detailed Design and Plans and Specifications.

Fig. 7.1. Comparison between threshold “ $(N_1)_{60}$ adjusted for fines” values and actual data for station ranges. ●...●: liquefaction probable. ○...○: liquefaction not expected. x...x: Cohesive (clayey) soils.

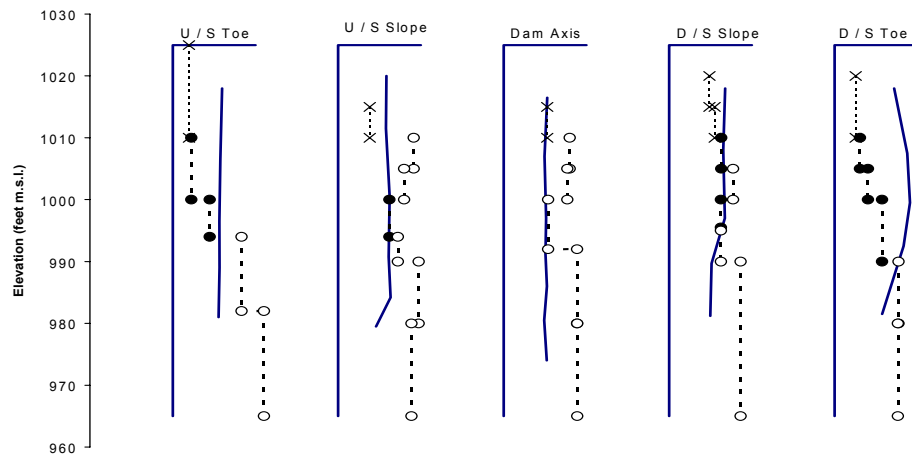
c. Stations 35+00 to 70+00.

(3) Based on Figure 7.1.c, it is evident that between stations 35+00 and 70+00 sand in the foundation is liquefiable between elevations 1010 and 994 under the lower portion of the upstream slope and between elevations 1010 and 990 under the lower portion of the downstream slope.
